## 10.0 Lowman, Idaho, Disposal Site

### 10.1 Compliance Summary

The Lowman, Idaho, Disposal Site, inspected on July 17, 2007, was in excellent condition. Noxious weed infestations continue to be monitored and sprayed with herbicide; populations of the weeds have been reduced significantly. No cause for a follow-up or contingency inspection was identified.

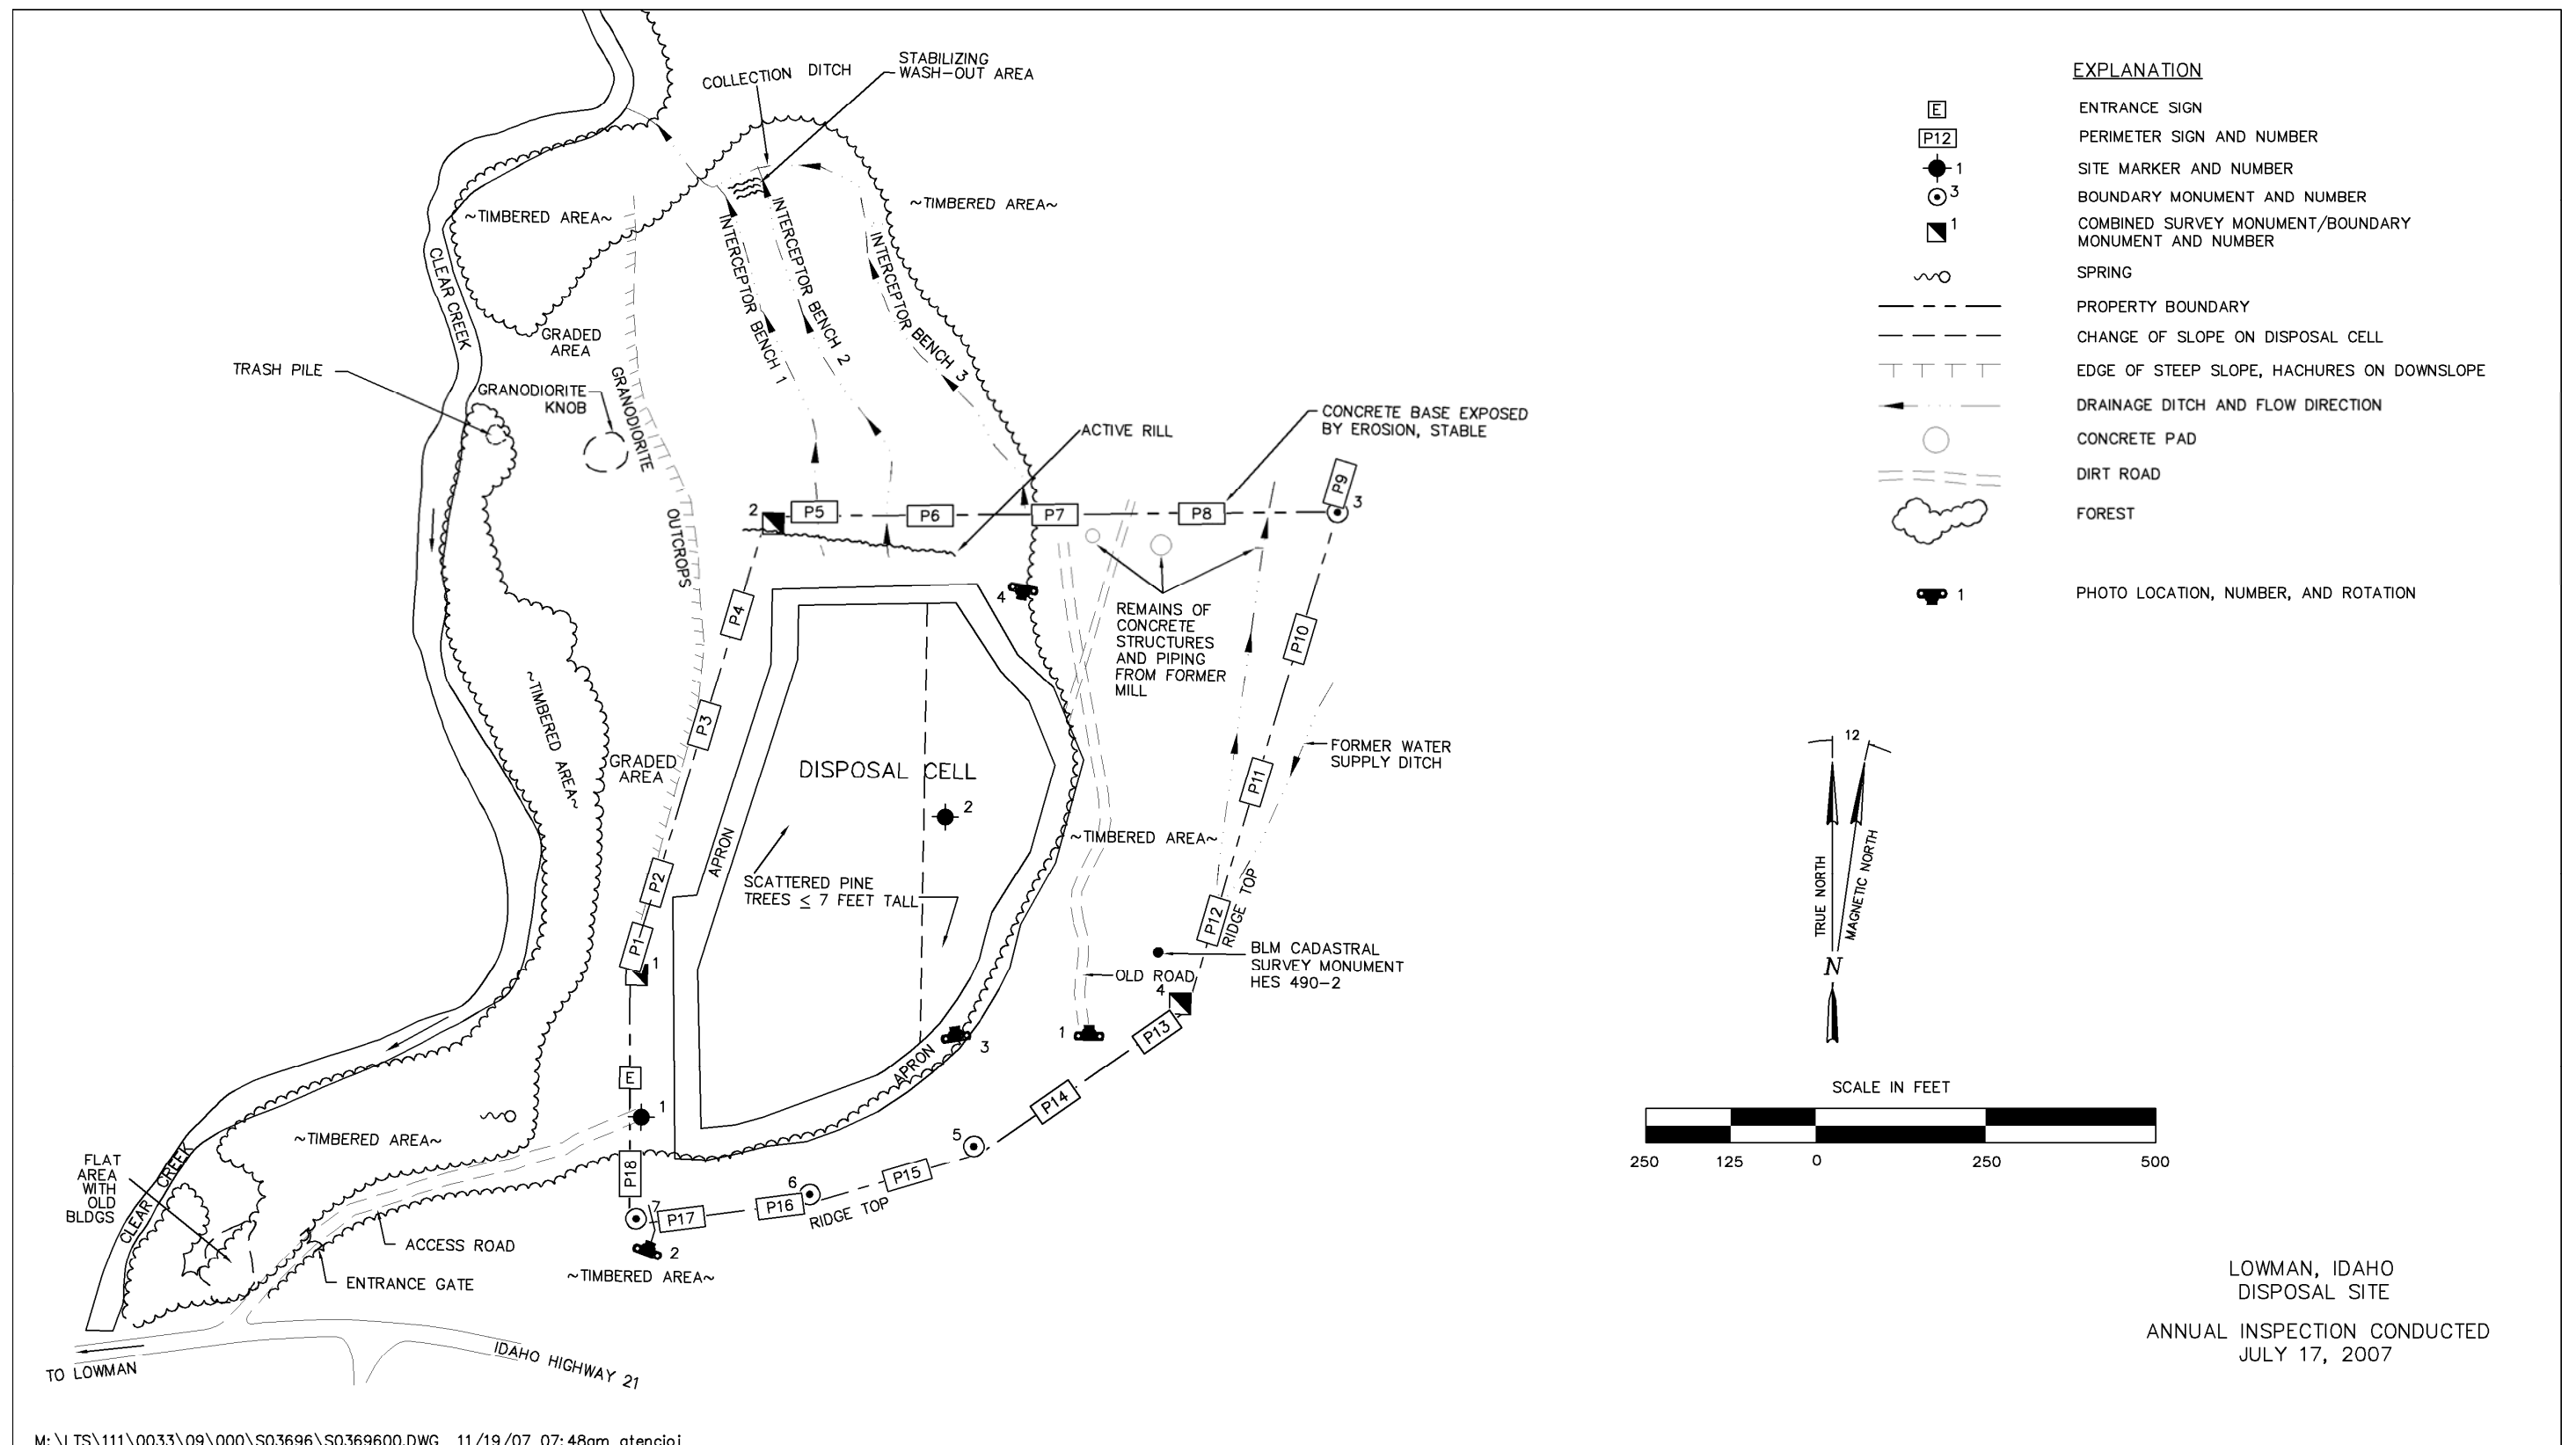
Figure 10–1. 2007 Annual Compliance Drawing for the Lowman, Idaho, Disposal Site

**Top and Side Slope of the Disposal Cell**—The 8-acre disposal cell was completed in 1991. Basalt riprap armors the top and west-facing side slope of the disposal cell. An apron of larger riprap surrounds the disposal cell on all sides. The riprap was in excellent condition, and no evidence of instability, such as subsidence, slumping, or cracking was observed on any of the cell surfaces (PL-2 and PL-3).

Vegetation encroachment by species including ponderosa pine continues on the top and side slopes of the disposal cell (PL-2, PL-3, and PL-4). Encroachment is a natural process operating at this location and will be allowed to continue in accordance with the LTSP. Although DOE is no longer required to remove pine trees as they mature, the revised LTSP states that DOE will repair any damage that may occur to the riprap cover and underlying cover layers caused by blowdown or other processes to maintain protection from erosion and possible consequent dispersion of cell contents. The largest ponderosa pine trees on the cover are now approximately 7 feet tall.

**Area Between the Disposal Cell and the Site Boundary**—The steep slopes east and south of the site are stable and vegetated with well-established grasses and ponderosa pine trees. One active erosion rill was previously discovered along the north boundary of the site adjacent to perimeter signs P5 and P6; it had bisected the berms of the lower two interceptor benches. The breach in Interceptor Bench 1 was repaired in October 2004, and the breach in Interceptor Bench 2 was repaired in June 2005. Both repairs were in excellent condition.
